The reasons for architectural monuments destruction and methods of capacity reinforce for bases and fundaments

Mykola Orlenko

Abstract. The main problem of monuments' emergency state is poor condition of the bases and foundations often due to their moisture. Uneven foundations subsidence leads to redistribution of efforts in bearing constructions and static instability of the base-foundation-building system. That's why any restoration starts with the removal of their emergency state.

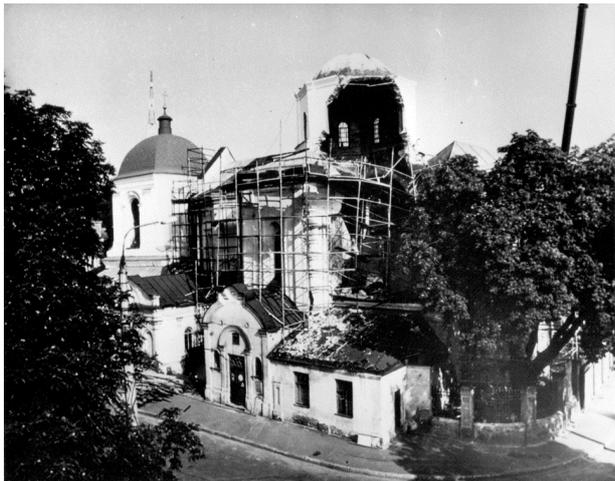
Fig.2. Alert condition of the Mykola Pritisk's church (Photo May 1983)

rier pylon and two reinforcing arches, which were based on it, cylindrical vaults and three sides of an octagonal drum were destroyed (Figs.2, 3).

The main reasons for the alert condition of the monument were raising the level of groundwater in recent years after the construction of the subway at Podil, which was like a dam and blocked the flow from Tarasivska and Zamkova mountains in the Dnieper, uneven subsidence of foundations that caused redistribution for efforts in carrying structures, which destroyed previously established balance in the base-foundation-building system.

Comparing the technical and economic parameters, as well as the considered options, the most rational was the use of root piles (Figs. 9 – 15).

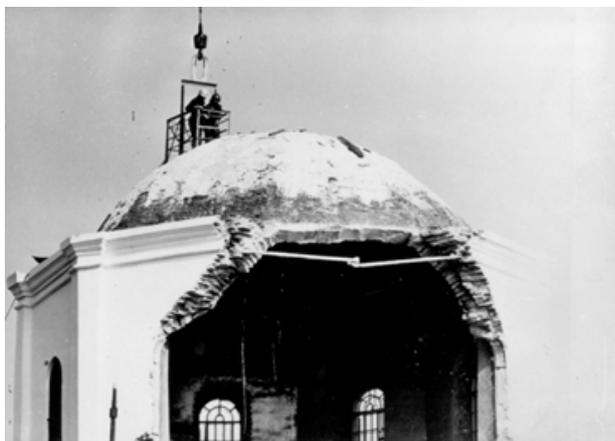
Fig.3. Part of Mykola Pritisk's church octagonal drum

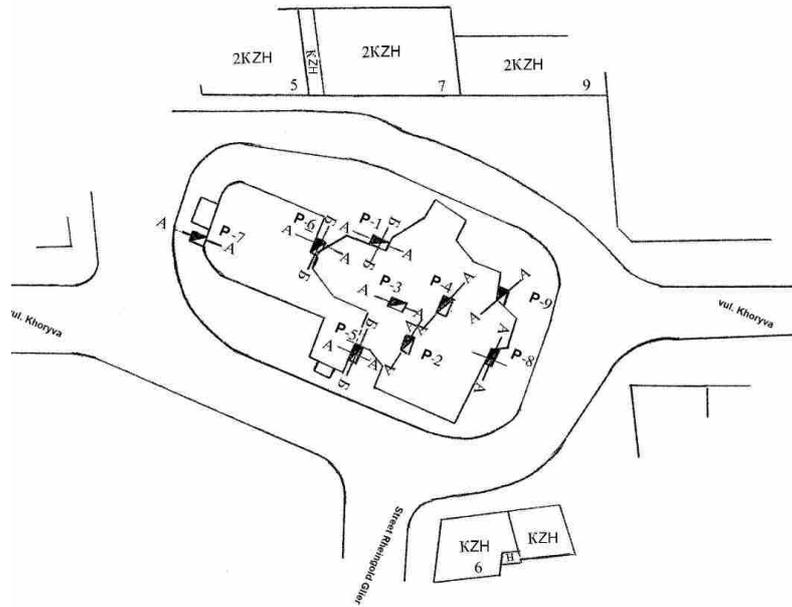
Fig.4. Layout for pits

To elucidate and clarify the reasons for the alert condition of the church, Ukrainian main state institute of engineering studies (UkrDI-INTD) performed a complex field, laboratory and cameral geological studies technical report in 1983 [11]. In 1984, 9 pits were made in addition to the previous studies to clarify the soil structure of the base and foundation material (Fig.4).

The foundation material, as it is seen from the pits, is uniform. In the pits number 1, 4 and 5, the foundation is made of bricks on limestone mortar. In the pits number 2, 3, 6 and 7, the foundation is made of rubble masonry (slab and granite boulders of 100 cm). The sole rubble foundations are located at a depth of 2,4 to 3,55 meters. After the rubble masonry, the brick masonry, which goes to the surface, is made. Sand and brickbat are used as a filler in the masonry. The masonry within the foundation in the pits 5, 8, and 9 has a vertical crack of 2 cm wide. Sections see Figs.5 – 8.

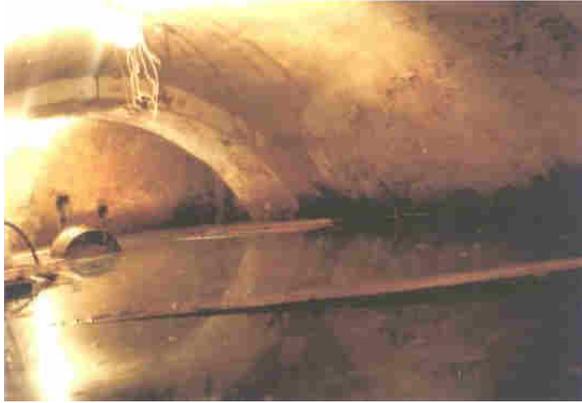
Basement moisture condition (Fig.16) was unsatisfactory, the basement was underflooded all the time and water was always there. The water level rose to a height of 40...50 cm from the floor and depended on changes in the level of groundwater. Moisture of the plaster exceed permissible limits, plaster was covered with efflorescence. In some places, there was peeling, breaking, and some heavy losses of laying bricks. In the north wall, bricks inrush amounted to 15 cm, cracks in walls and arches reached up to 30 mm.

Analysis of the moisture condition for the laying lower sections of the walls testified that the moisture for the walls was significantly

higher than the permissible limits and reached above 12...14%, resulting in lesions of building materials with *Micromycetes* fungi complex and caused the plaster and brickwork destruction. Moisture indicators in the interior walls of the church basement were lower and showed existing capillary suction of moisture.

Fig. 16. Basement before the work

3. To normalize moisture and the state of the walls, and to prevent the ingress of water into the basement, vertical and horizontal waterproofing must be performed.

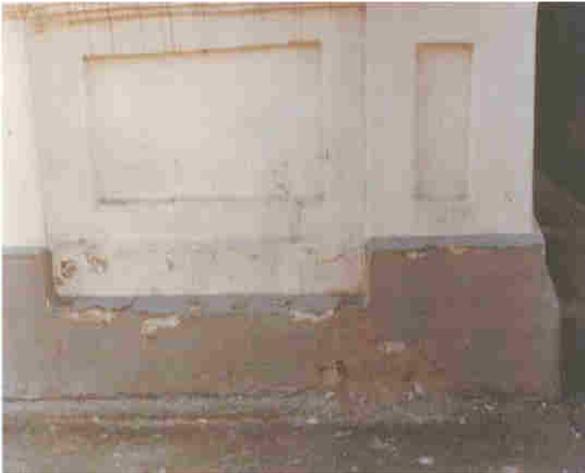
Fig.17. Basement before the work

1. Drainage for the moisture of the basement (Fig.17).

- removing destroyed plaster;
- destructive laying disassembly;
- surface dedusting;
- replacing for the lost bricks with the new;
- crack injection with the mortar;
- bricklaying mortar restoration and joints filling with AISIT Grundputz;
- dust cleaning for the holes;
- filling holes by 2 – 3 injection with AIDA KEISOL;
- two antifungal treatments for the walls;
- holes treatment with AIDA Borlochsuspension;
