The reasons for architectural monuments destruction and methods of capacity reinforce for bases and fundaments

Mykola Orlenko

Abstract. The main problem of monuments' emergency state is poor condition of the bases and foundations often due to their moisture. Uneven foundations subsidence leads to redistribution of efforts in bearing constructions and static instability of the base-foundation-building system. That's why any restoration starts with the removal of their emergency state.

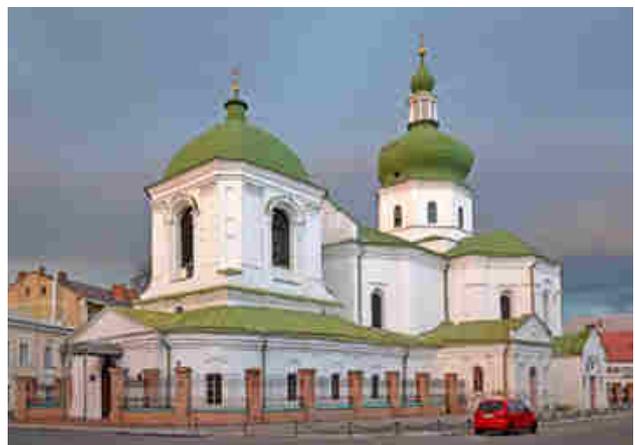
Fig.1. General view of Mykola Pritisk's church

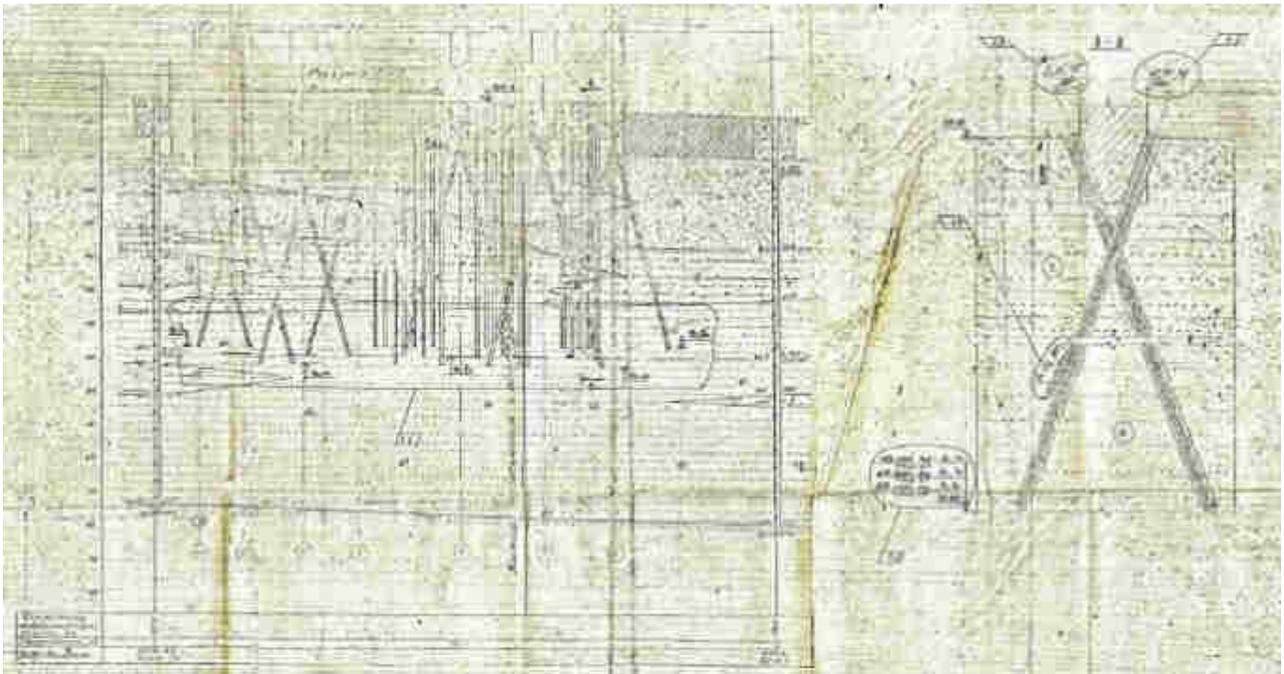
Fig.10. Scheme for putting building on the geological section

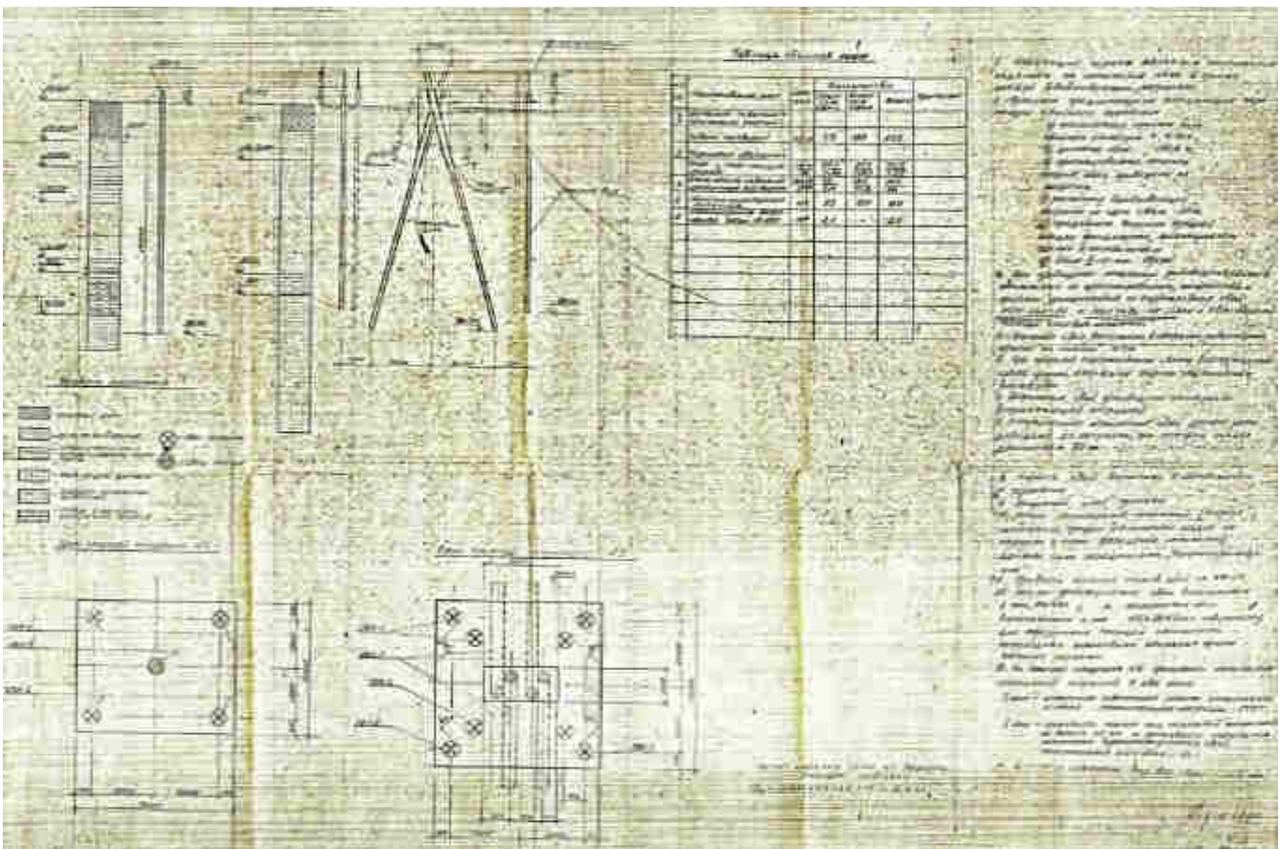
Fig.11. Test for the pile in the soil by axial load

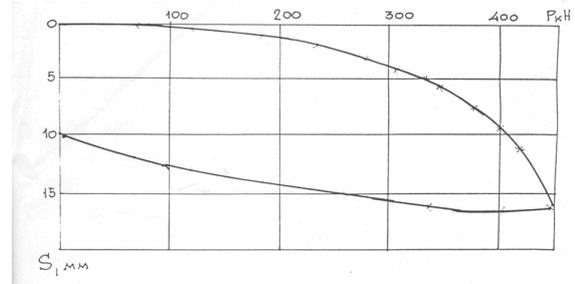
Fig.13. $S = f(P)$ plot for the studied root pile DP-1 at strengthening the foundations of the Mykola Pritisk's church in Kyiv

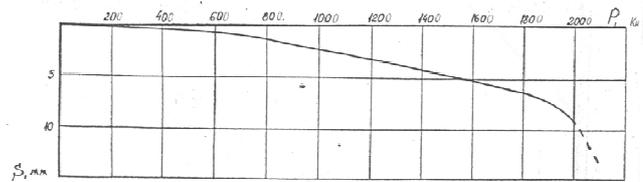
Fig.14. $S = f(P)$ plot for the studied cluster of four root piles, connected with DR-1 rostverk at strengthening the foundations of the Mykola Pritisk's church in Kyiv

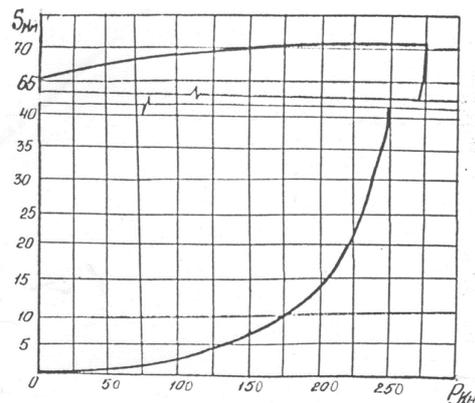
Fig.15. $S = f(P)$ plot for the studied root pile DP-1 on the break at strengthening the foundations of the Mykola Pritisk's church in Kyiv

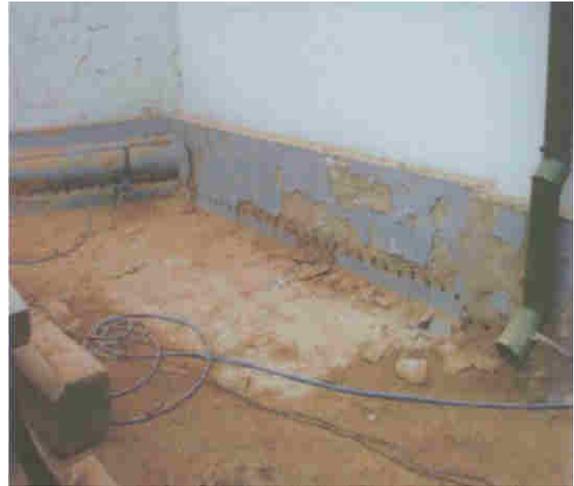
Fig.18. Drilling holes in the basement facade

Drilling of holes was performed according to the technology (Figs.18 – 22).

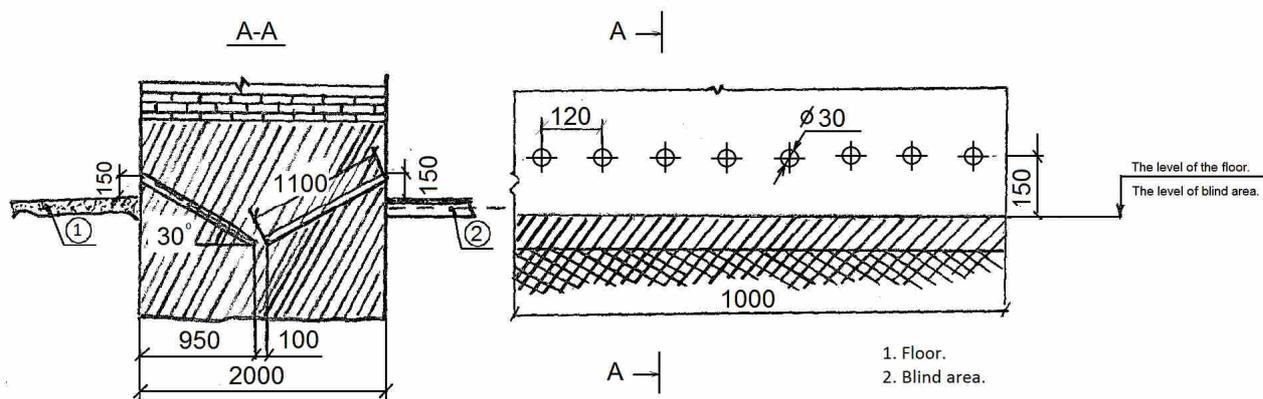
Fig.20. Layout for the holes

Holes were drilled in the walls around the perimeter of the church outside the basement (see Fig.19), in places, where the wall thickness is more than 2 m – on both sides. At the altar, the drilling was performed only from outside. The depth of the holes and their location are shown at the layout (see. diagrams at the sheets).

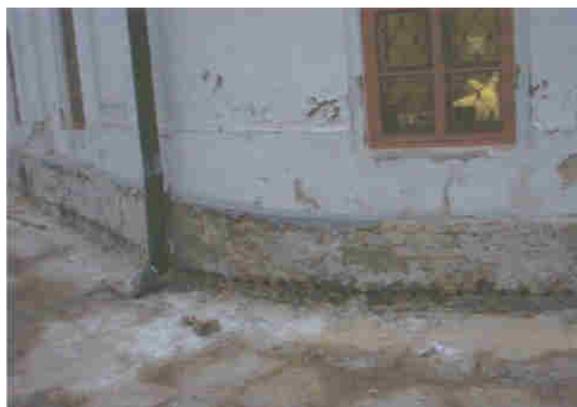
Fig.21. Drilling holes in the basement facade

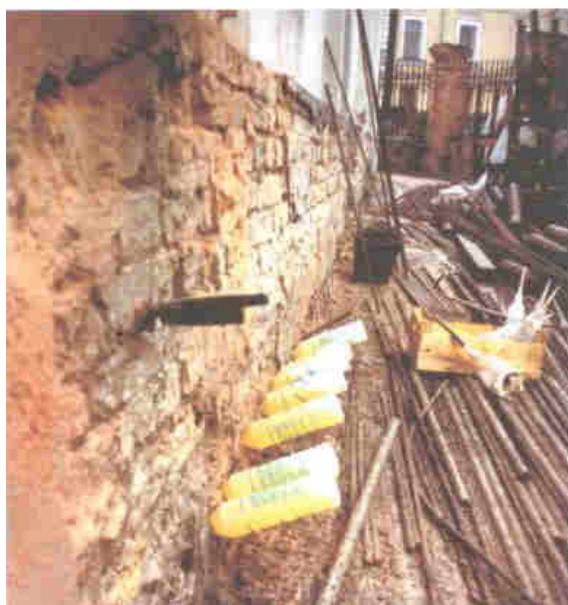
Fig.22. Fill in drilled holes with Aida KIESOL solution

After the full technological cycle of vertical and horizontal waterproofing arrangement, the moisture of the church walls, both outside and inside, become normal (Fig.23).
